| Date | Report No. | Order No. |
|---|---|---|
| 2017-10-19/2018-09-18 | 1709145S – Part 3 / 1710257MH Rev.1 | |

## **Inspection of Protector Testing according to API 5CT Ed. 2011 9<sup>th</sup> Edition Annex I**

Pipeconnector protectors were tested according to API 5CT. Therefore, some random protectors were taken from the production batches 20164107 and 20174467 to be tested.

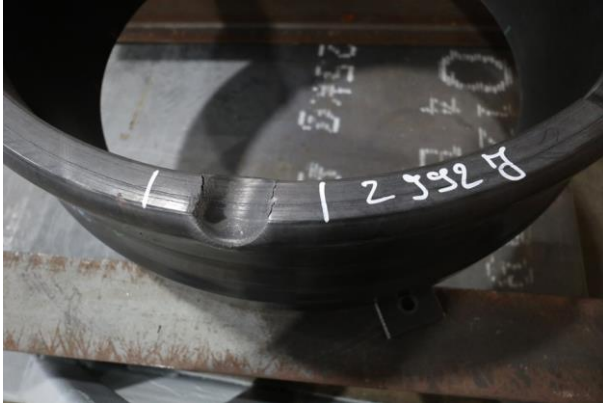
| Value | Requirement | Value | Evaluation |
|---|---|---|---|
| <b>Surface inspection of the machined surfaces</b> | No damage | Connector and threads found in good condition<br>No damage to the connector observable | passed |

Protector (1) after testing – impact energy 2992 J

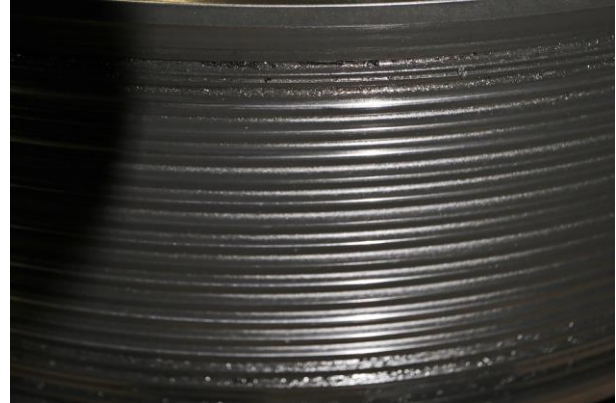
Connector threads after testing with 2992 J  
Protector (1)

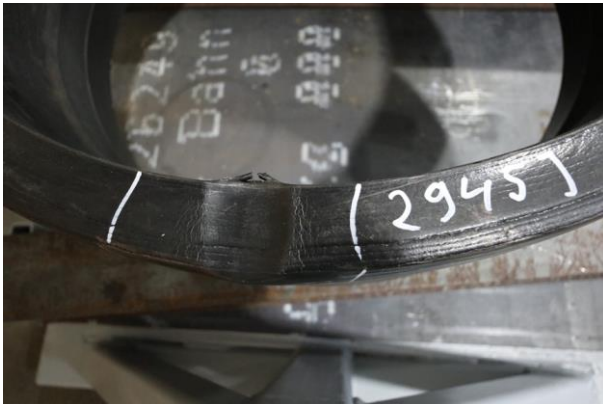
| Value | Requirement | Value | Evaluation |
|---|---|---|---|
| <b>Surface inspection of the machined surfaces</b> | No damage | Connector and threads found in good condition<br>No damage to the connector observable | passed |

Protector (2) after testing with 2945 J

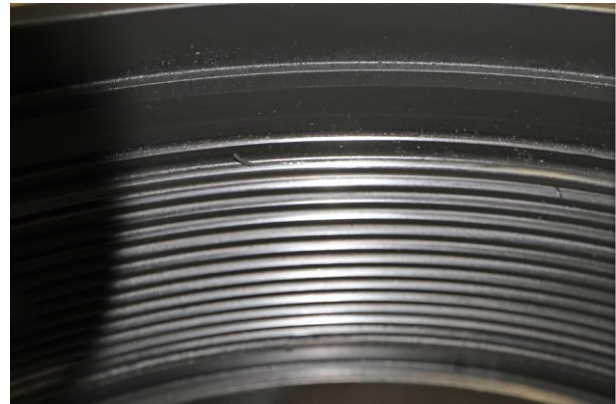
Connector threads after testing with 2945 J  
Protector (2)

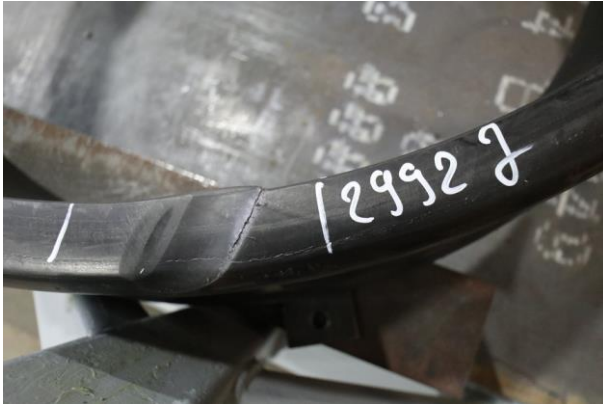
| Value | Requirement | Value | Evaluation |
|---|---|---|---|
| Surface inspection of<br>the machined surfaces | No damage on<br>the connector | Connector and threads found in good condition<br>No damage to the connector observable | passed |

Protector (3) after testing – impact energy 2992 J

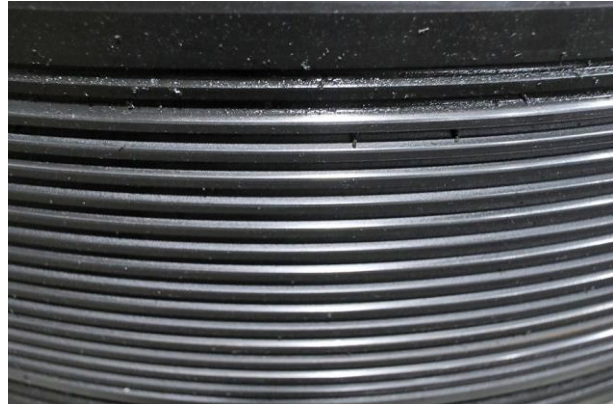
Connector threads after testing with 2992 J  
Protector (3)

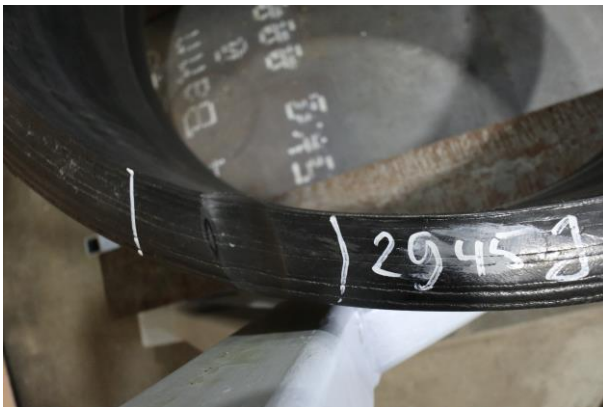
| Value | Requirement | Value | Evaluation |
|---|---|---|---|
| Surface inspection of<br>the machined surfaces | No damage | Connector and threads found in good condition<br>No damage to the connector observable | passed |

Protector (4) after testing with 2945 J

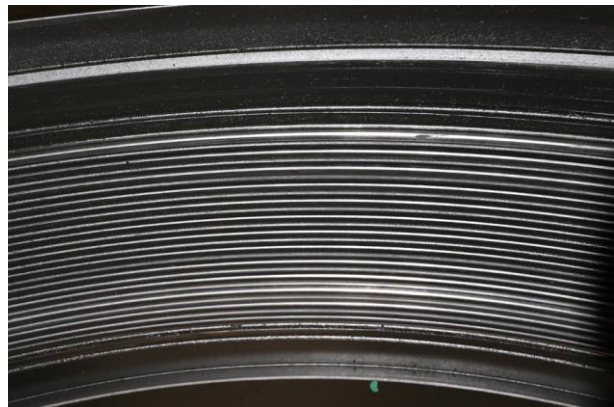
Connector threads after testing with 2945 J  
Protector (4)
