<b>Date</b>	<b>Report No.</b>	<b>Order No.</b>
<b>2018-08-23 / 2018-09-18</b>	<b>1808364MH Rev.1</b>	<b>-</b>

**Inspection of Protector Testing following API 5CT Ed. 2011 9<sup>th</sup> Ed.**

- **Threadless Protector PIN 26" x 1,25" with 4mm steel clamps                    black (4)**
- **Threadless Protector PIN 26" x 1,25" with 5mm steel clamps (var.1)    black (1)**
- **Threadless Protector PIN 26" x 1,25" with 5mm steel clamps (var.2)    black (2)**

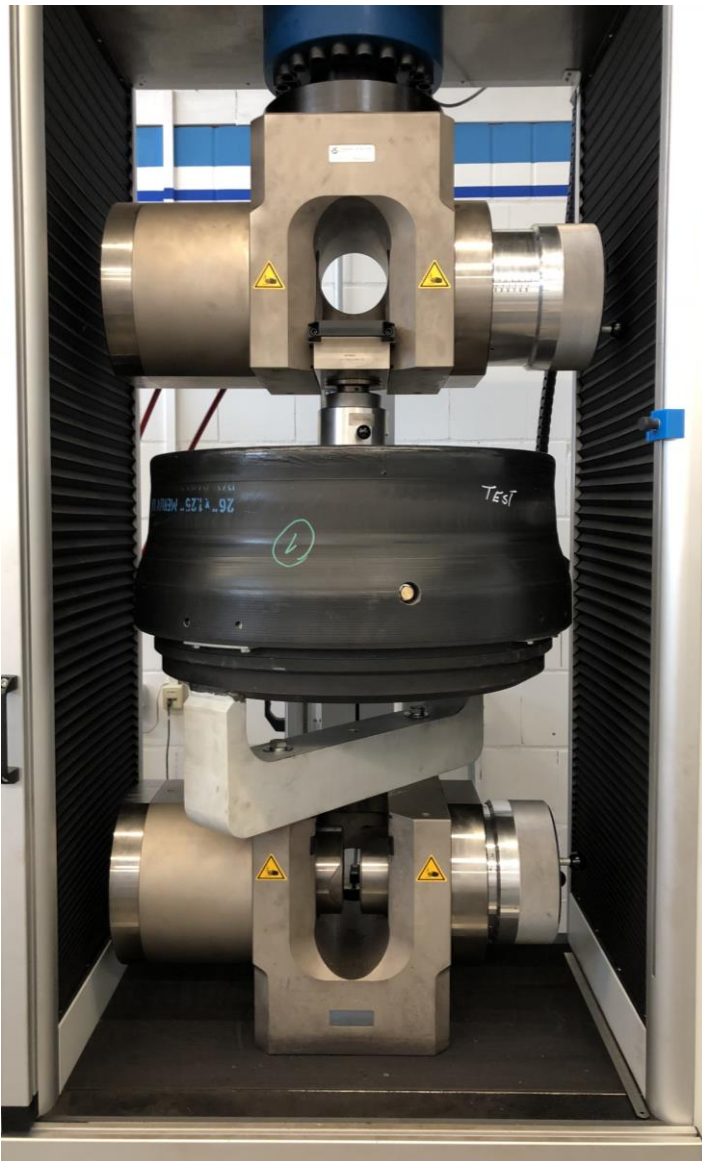
Testing device with installed protector (1)

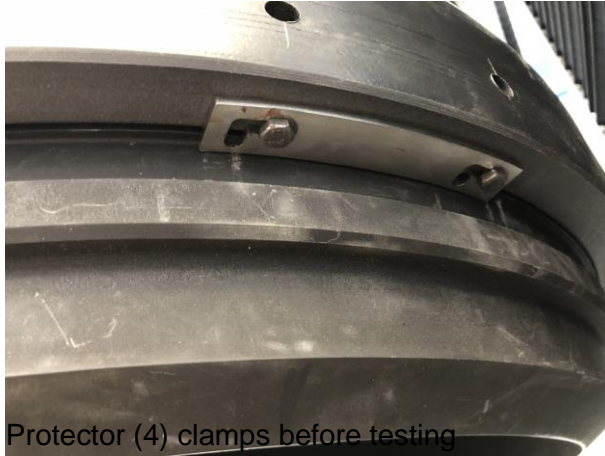
Protector (4) clamps before testing

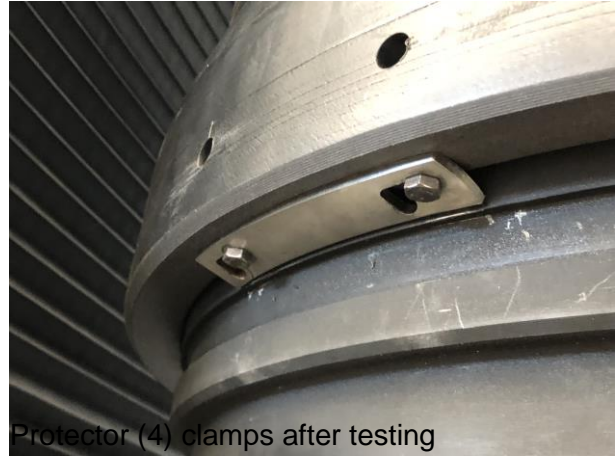
Value	Requirement	Value
<b>Maximum axial load</b>	For information	34,61 kN
<b>Surface inspection of the connector shape and surface</b>	No damage	Connector shape found in good condition Part failed: steel sheets Type of failure: steel sheets were bent Protector was still hold in place after the first break-loose No damage of the protector observable
<b>Inspection of the protector</b>	No damage	The protector was found in good condition. The protector material showed no damage.
<b>Steel clamps</b>	For information	The steel clamps were bent until they slipped over their counterpart.
<b>Remark</b>		Even after the initial slip, the clamps held the protector in place by jam up with the connector.

Protector (4) clamps after testing

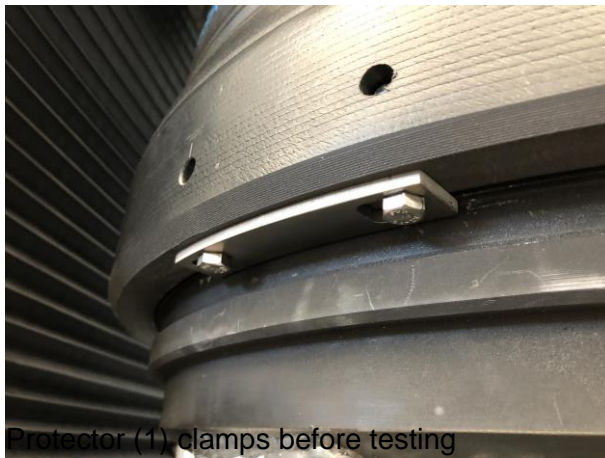
Protector (1) clamps before testing

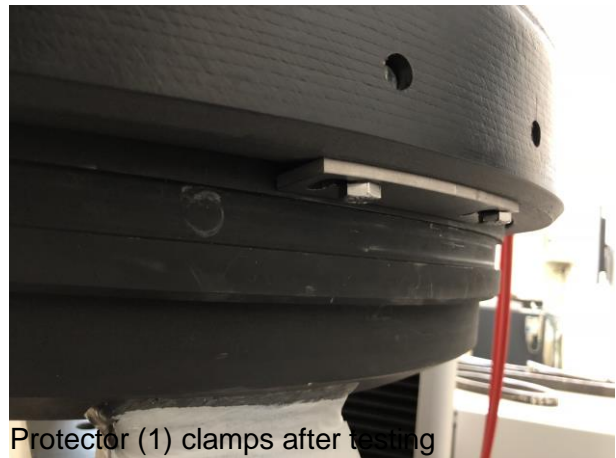
Value	Requirement	Value
<b>Maximum axial load</b>	For information	57,09 kN
<b>Surface inspection of the connector shape and surface</b>	No damage	Connector shape found in good condition Part failed: steel sheets Type of failure: steel sheets were bent Protector was still hold in place after the first break-loose No damage of the protector observable
<b>Inspection of the protector</b>	No damage	The protector was found in good condition. The protector material showed no damage.
<b>Steel clamps</b>	For information	The steel clamps were bent until they slipped over their counterpart.
<b>Remark</b>		Even after the initial slip, the clamps held the protector in place by jam up with the connector.

Protector (1) clamps after testing

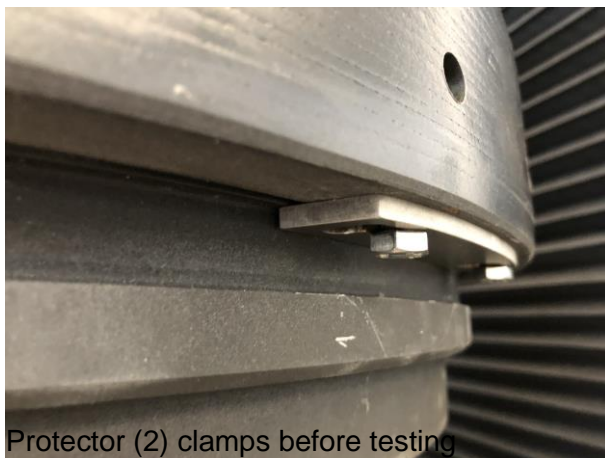
Protector (2) clamps before testing

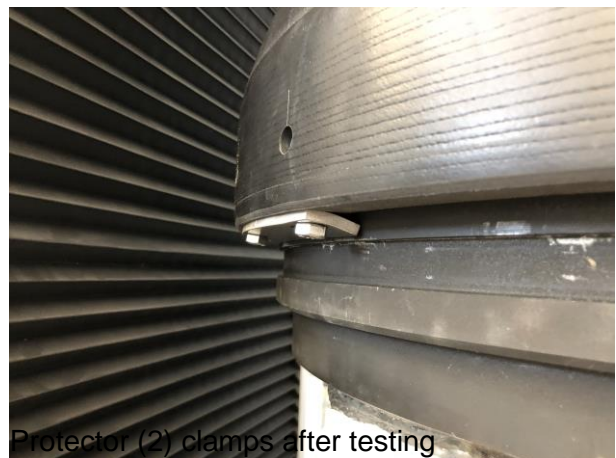
Value	Requirement	Value
<b>Maximum axial load</b>	For information	62,41 kN
<b>Surface inspection of the connector shape and surface</b>	No damage	Connector shape found in good condition Part failed: steel sheets Type of failure: steel sheets were bent Protector was still hold in place after the first break-loose No damage of the protector observable
<b>Inspection of the protector</b>	No damage	The protector was found in good condition. The protector material showed no damage.
<b>Steel clamps</b>	For information	The steel clamps were bent until they slipped over their counterpart.
<b>Remark</b>		Even after the initial slip, the clamps held the protector in place by jam up with the connector.

Protector (2) clamps after testing
