TECHNICAL REPORT No.2021-0176-01-r00

Vibration test of protectors – 1 pc 24" × 0.688" Box protector and 1 pc 24" × 0.688" Pin protector. The test was performed according to the standards EN 60068-2-6 ed. 2.

Project: EXQUIP-test_of_thread_loosening-2101
Offer number: 2021-0176-01 of 10th November, 2021
Order number: 2021-0176-01 of 21st January, 2022
Release date: 25.2.2022

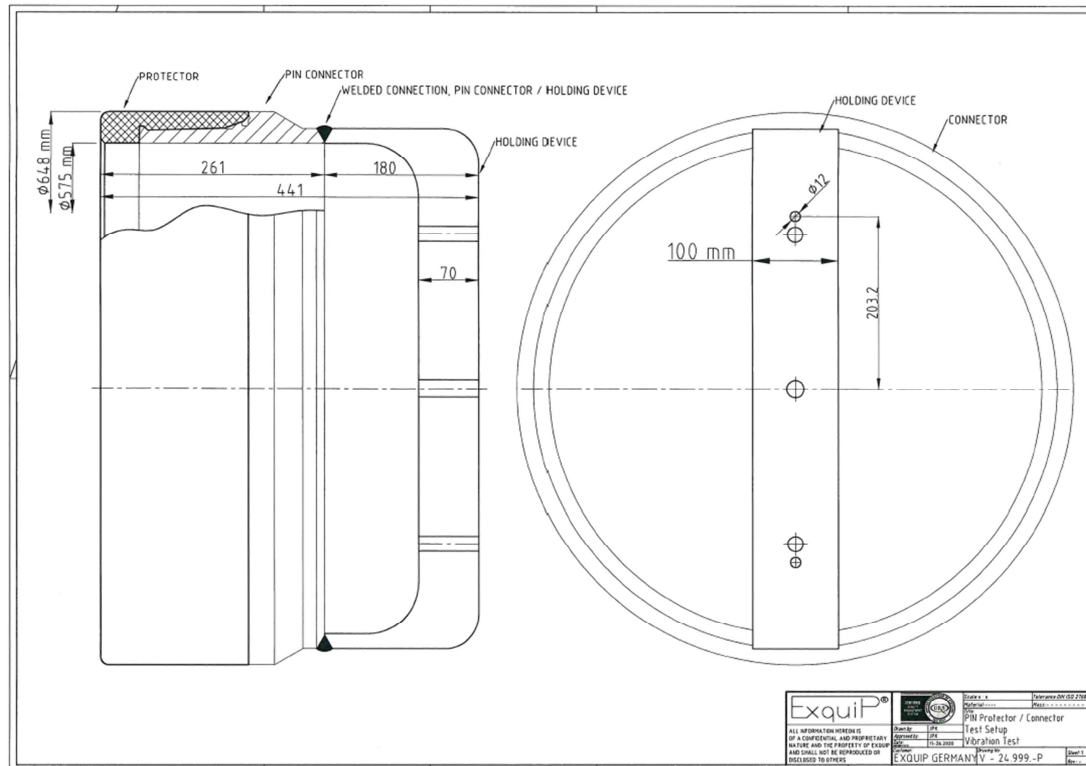
Test specimen no. 1 was composed of 24" Pin connector and 24" Pin protector, see Fig. 1.

Fig. 1 – Test specimen no. 1

Two holes were drilled into the holding device. These holes are located 101.6 mm (4 inches) from central axis of 24" Pin protector.

Test specimen no. 1 was mounted on the armature of electrodynamic shaker by 5 pcs of bolt M10, tensile grade 8.8 and 4 pcs of plain clamps with bolts M10, tensile grade 8.8, see Fig. 3. Tightening torque 50 Nm was used for bolts.

24" Pin protector was screwed on Pin connector. Tightening torque 200 Nm was used for Pin protector.

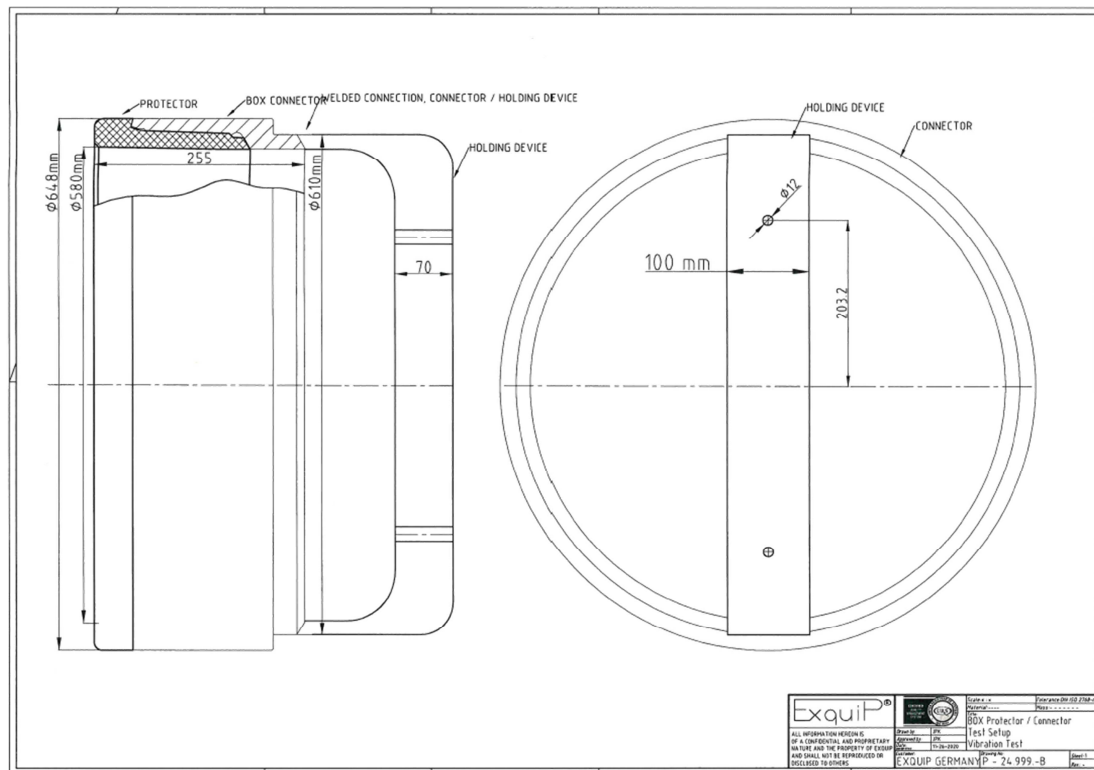
Test specimen no. 2 was composed of 24" Box connector and 24" Box protector, see Fig. 2.

Fig. 2 – Test specimen no. 2

Four holes were drilled into the holding device. These holes are located 101.6 mm (4 inches) and 203.2 mm (8 inches) from central axis of 24" Box protector

Test specimen no. 2 was mounted on the armature of electrodynamic shaker in the same way as test specimen no. 1.

24" Box protector was screwed on Box connector. Tightening torque 200 Nm was used for Box protector.

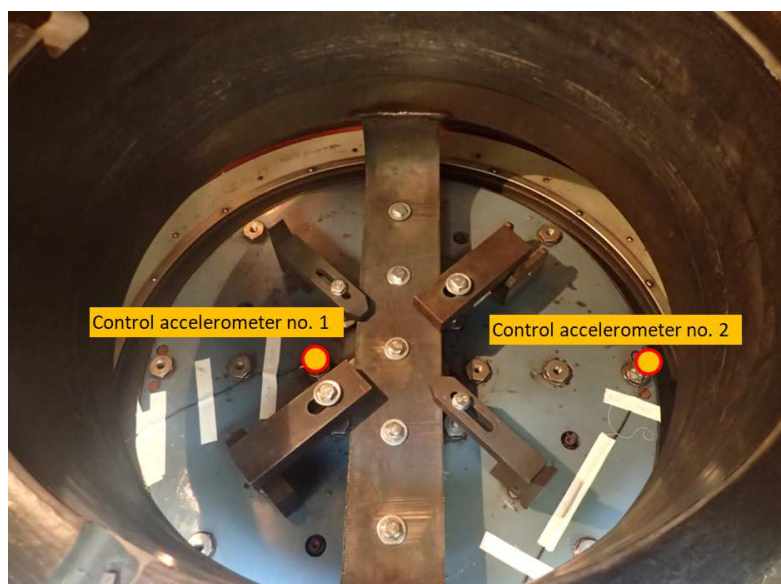
Two acceleration sensors were placed on the armature of the electrodynamic shaker, see Fig. 3. Both accelerometers were fixed with bolt and were used for vibration control of electrodynamic shaker. Vibration control strategy arithmetic mean from both acceleration sensors was used.

Fig. 3 – Acceleration measurement points

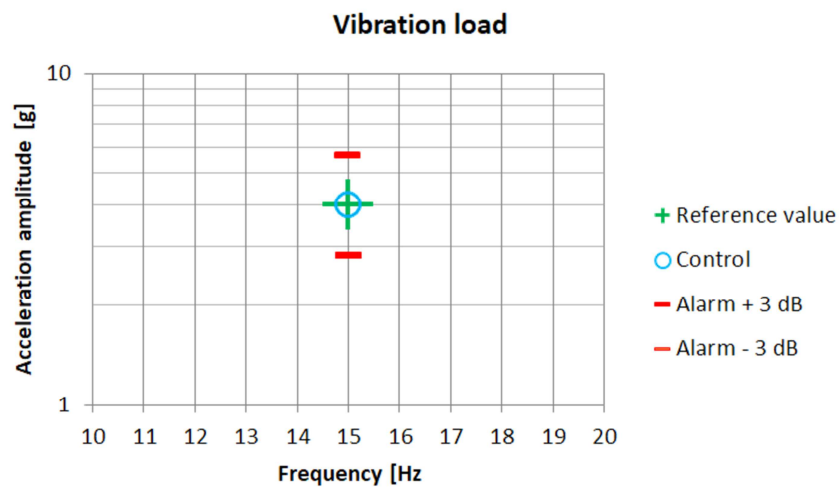
Appendix 1 – Vibration load

The vibration load acting on the test specimens during vibration durability test is shown in the Appendix 1, Fig. 4.

Fig. 4 – Vibration load

- Vertical vibration: amplitude 8.4 mm, acceleration 4 g,
- Frequency of vibration: 15 Hz, 900 cycles per minute, total 1.000.000 cycles,
- Ambient temperature: 23±5 °C.

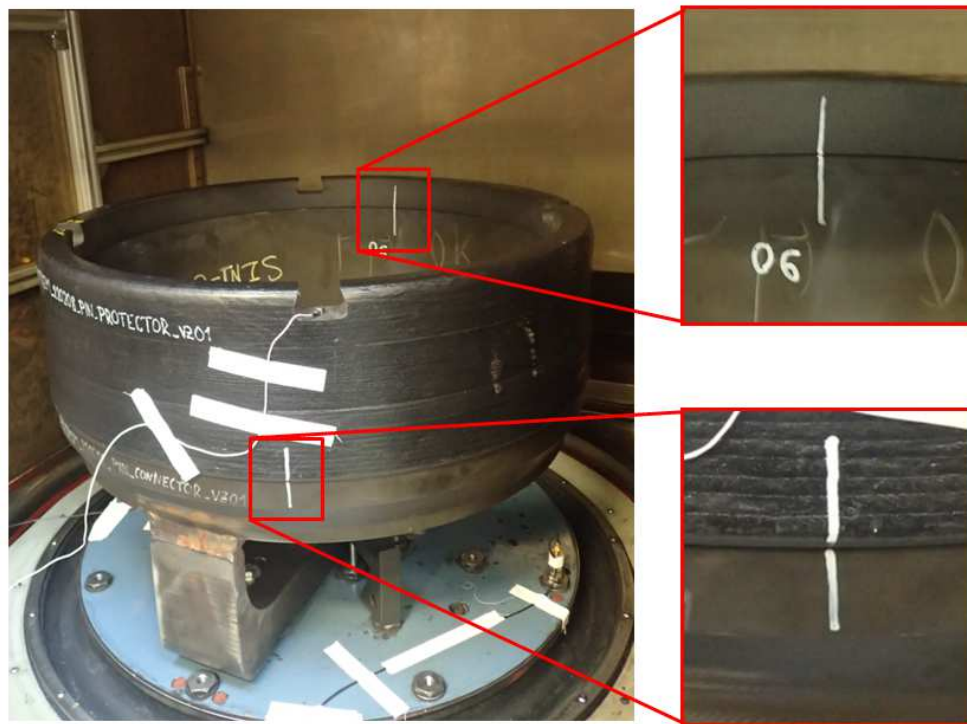
Appendix 2 – 24" Pin protector after vibration durability test

The 24" Pin protector did not loosen during vibration durability test.

24" Pin protector release torque was 180 Nm after the vibration durability test.

The 24" Pin protector was without visible damage after the vibration durability test.

Fig. 5 – 24" Pin protector after vibration durability test

Photo documentation of 24" Pin protector after the vibration durability test is in Appendix 2, Fig. 5

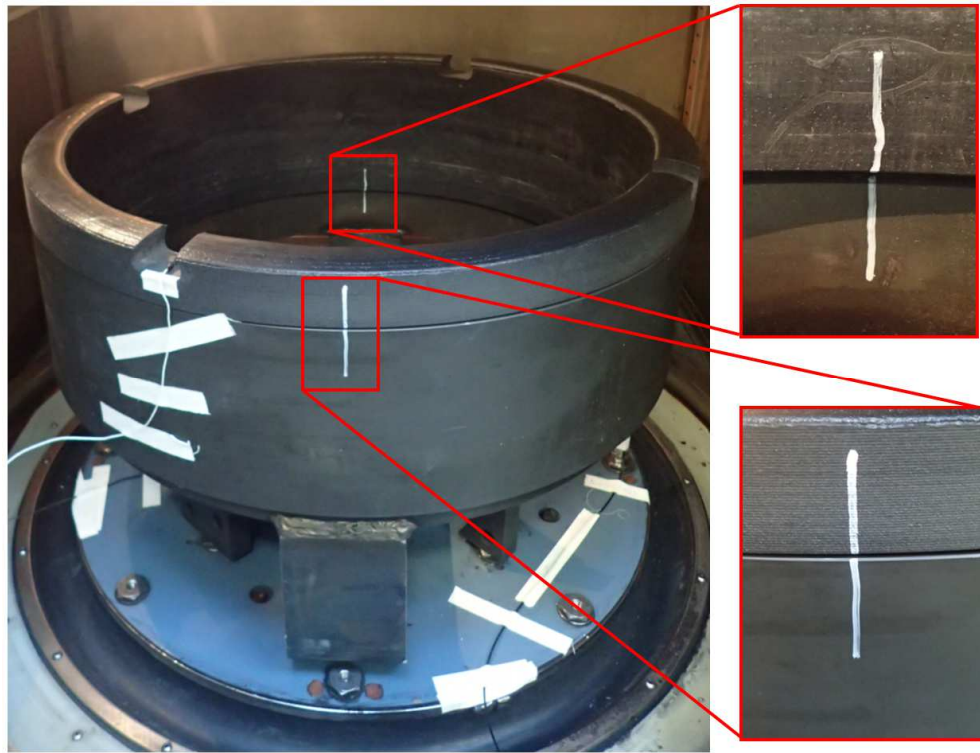
Appendix 3 – 24” Box protector after vibration durability test

The 24" Box protector did not loosen during vibration durability test.

24" Box protector release torque was 130 Nm after the vibration durability test.

The 24" Box protector was without visible damage after the vibration durability test.

Fig. 6 – 24” Box protector after vibration durability test

Photo documentation of 24" Box protector after the vibration durability test is in Appendix 3, Fig. 6
