Axial Impact Test Overview

For 24” x 0.688” PIN & BOX Protectors

Axial Impact Test @ -36°C (Cold Weather)

Tested protectors:	24” x 0.688” PIN Protector (Exquip)
Protector Material:	Exquip Polypropylene
Issue Date:	29-OCT-2020
Revision:	0

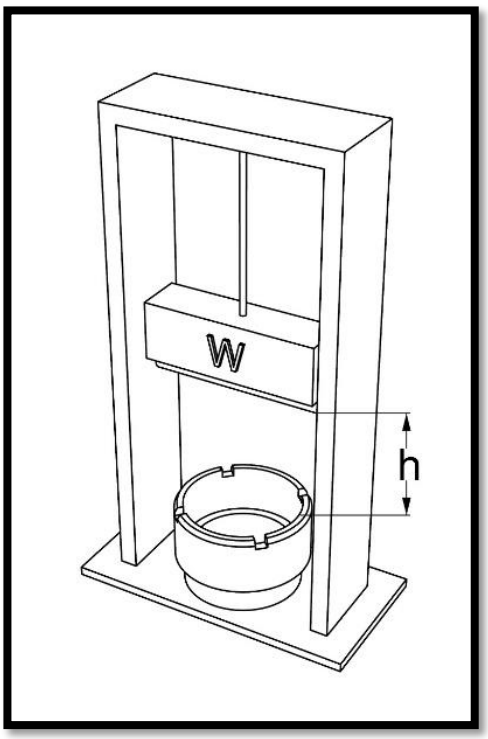
Axial Impact Test at cold temperature, hammer weight (W): 254 kg; protectors cooled down to a min. -36°C in a freezer for a min. of 4 hours.

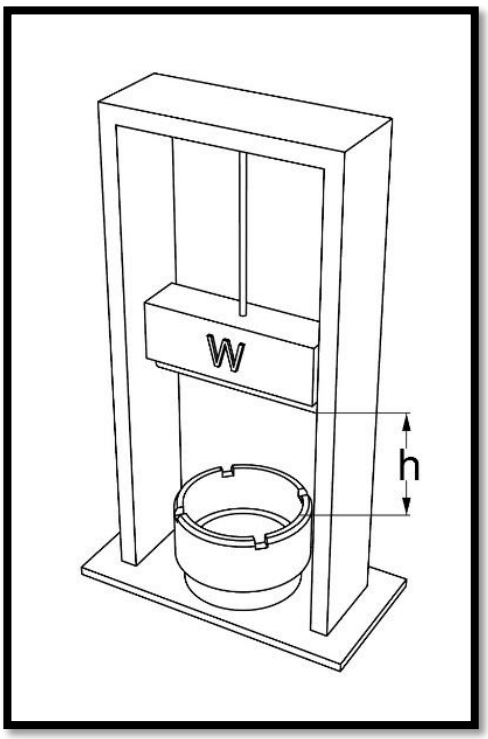
Angular Impact Test at cold temperature, hammer weight (W): 254 kg; protectors cooled down to a min. -36°C in a freezer for a min. of 4 hours.
